February 1944 as
Advance Restricted Report 4B02

FLIGHT TESTS OF THE THERMAL ICE-PREVENTION
EQUIPMENT ON THE B-17F AIRPLANE

By Bonne C. Look

Ames Aeronautical Laboratory
Moffett Field, California

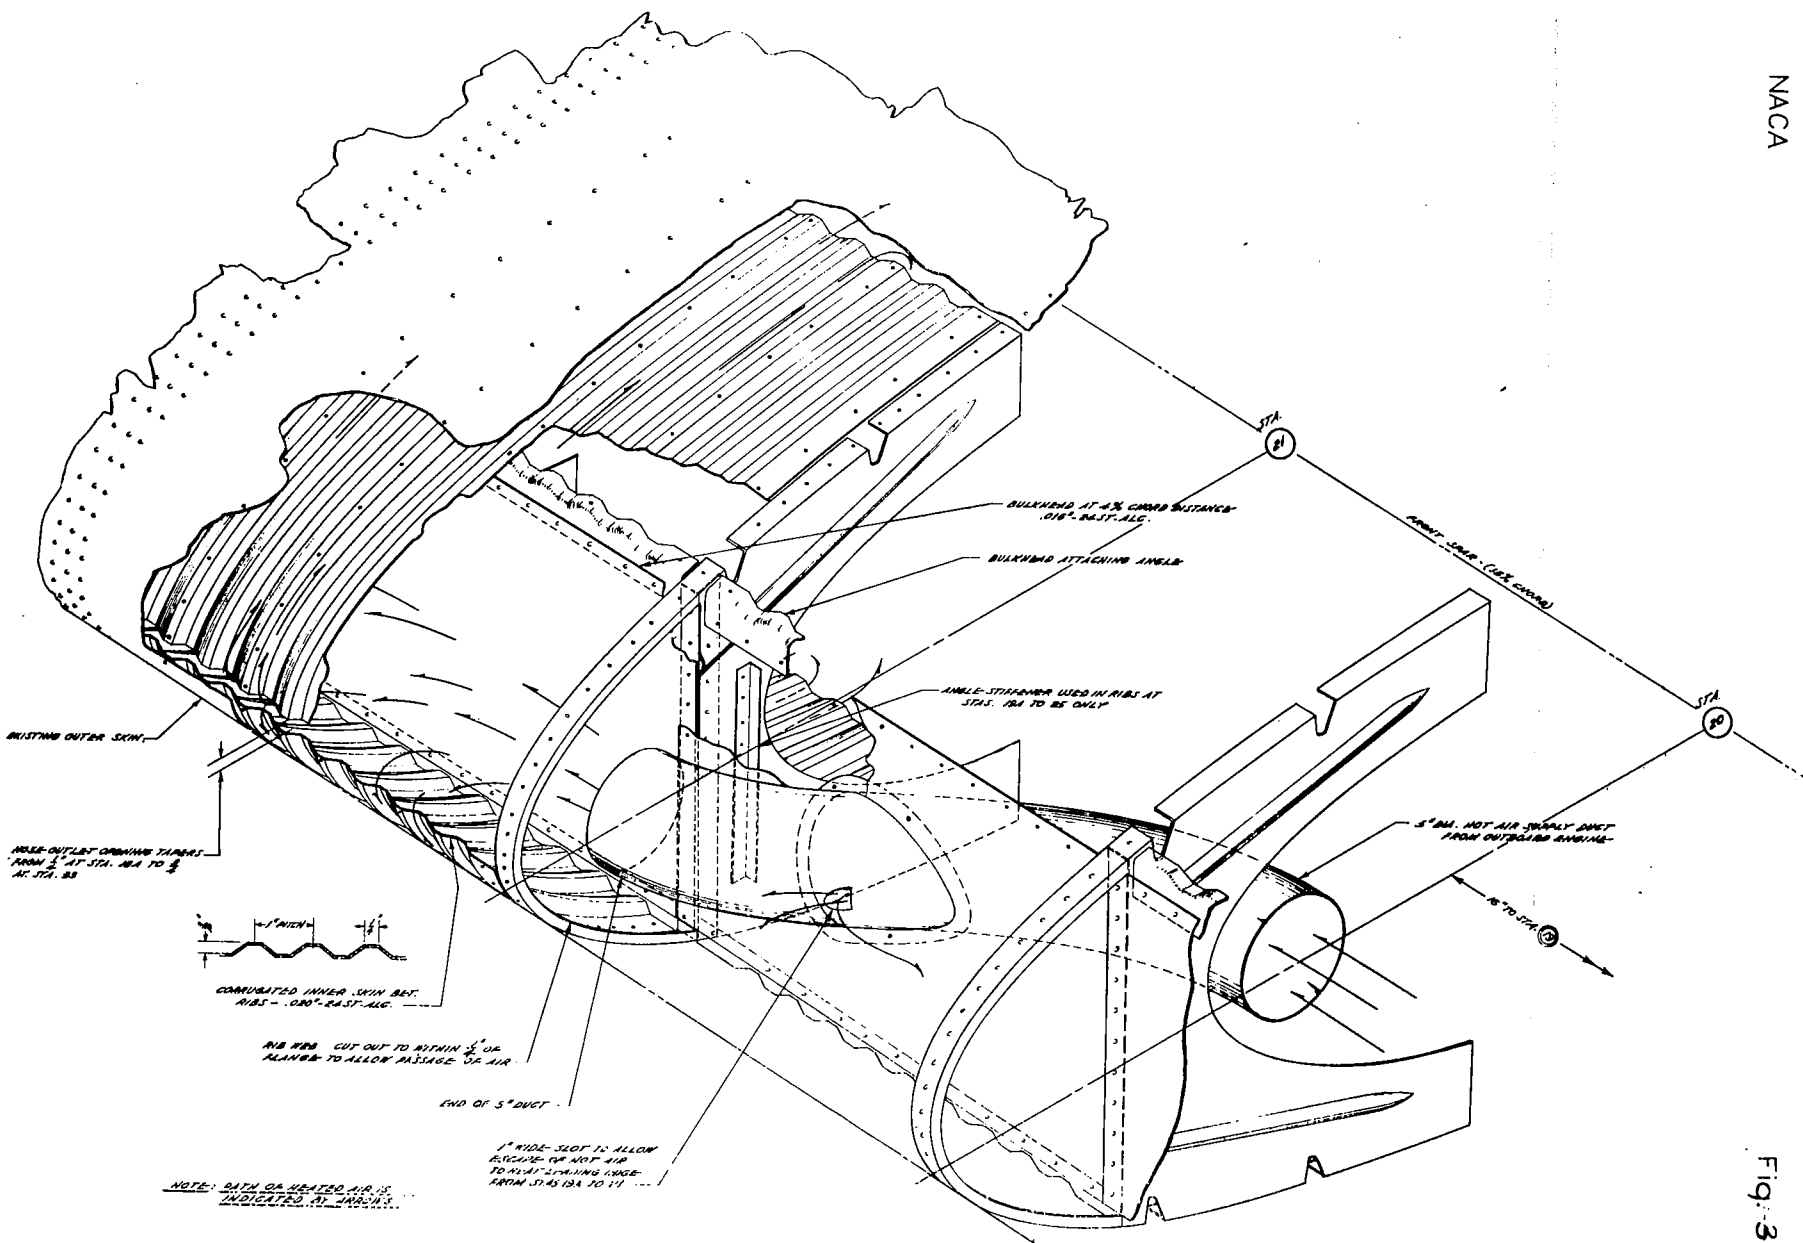
FIGURE 3.- DETAILS OF WING OUTER-PANEL LEADING-EDGE DESIGN FOR B-17F THERMAL ICE-PREVENTION SYSTEM.

The design of the ice-prevention system was based upon a spanwise air temperature drop of 40° F. For the icing flights the average spanwise air temperature drop between stations $22\frac{1}{2}$ and 33 was 49° F and for the dry-air flights was 34° F. The reversal of the spanwise gradient of the heated air and skin temperatures between stations $22\frac{1}{2}$ and 20 was probably due to the method by which the heated region between stations 20 and 21 was supplied with heated air (fig. 3).

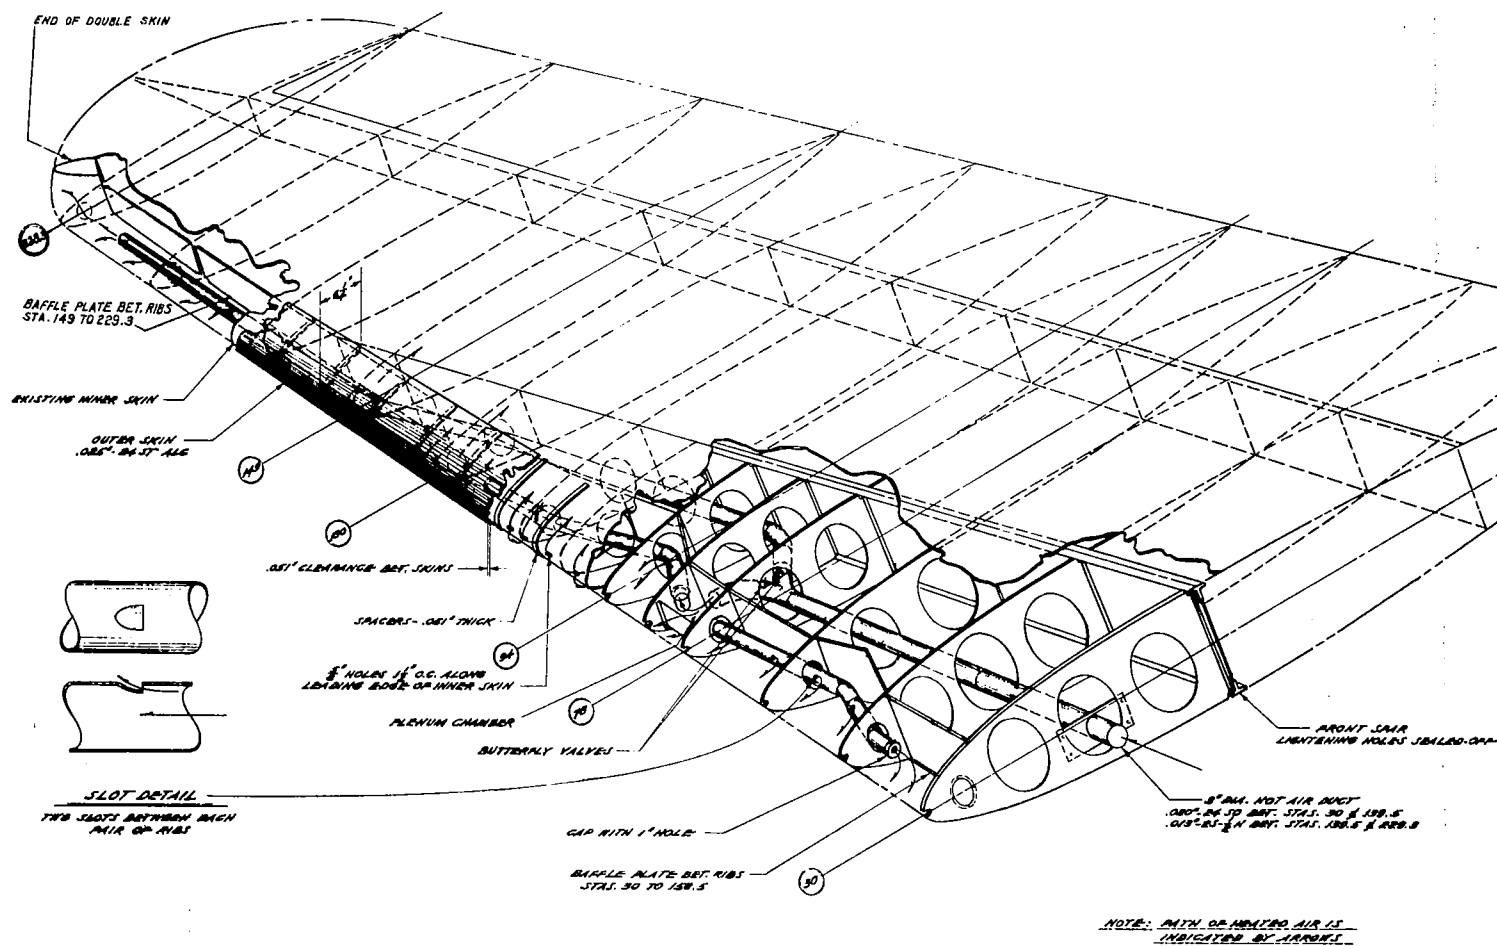
FIGURE 6.- HORIZONTAL STABILIZER DESIGN FOR B-17F THERMAL ICE-PREVENTION SYSTEM.

The ice formations which accumulated on the leading edge of the horizontal stabilizer were found to be at the inboard, midspan, and tip regions where the distribution duct had been discontinued and the heated air discharged into a chamber through a 1-inch-diameter hole in the end of the duct (fig. 6). The thermocouples which indicated the leading-edge skin temperatures were located in or near the regions where ice accumulated and, therefore, may not give a true indication of the temperature rise of the protected portion of the leading edge. The thermal data, given in table IV for the horizontal stabilizer, show an average skin temperature rise for the leading edge of approximately 30° F for tests 1, 3, 4, and 5, and 65° F for test 7. During the dry-air flights (tests 2 and 6) the average skin temperature rise was approximately 40° F. The increase in engine power conditions (test 5) did not materially affect the skin temperature rise or the degree of protection afforded by the ice-prevention system. The heated-air flow rate to the horizontal stabilizer was not obtained, but the total weight of air supplied to the empennage group was determined and the distribution of the air to the horizontal and vertical stabilizers was based upon the skin temperature rises.

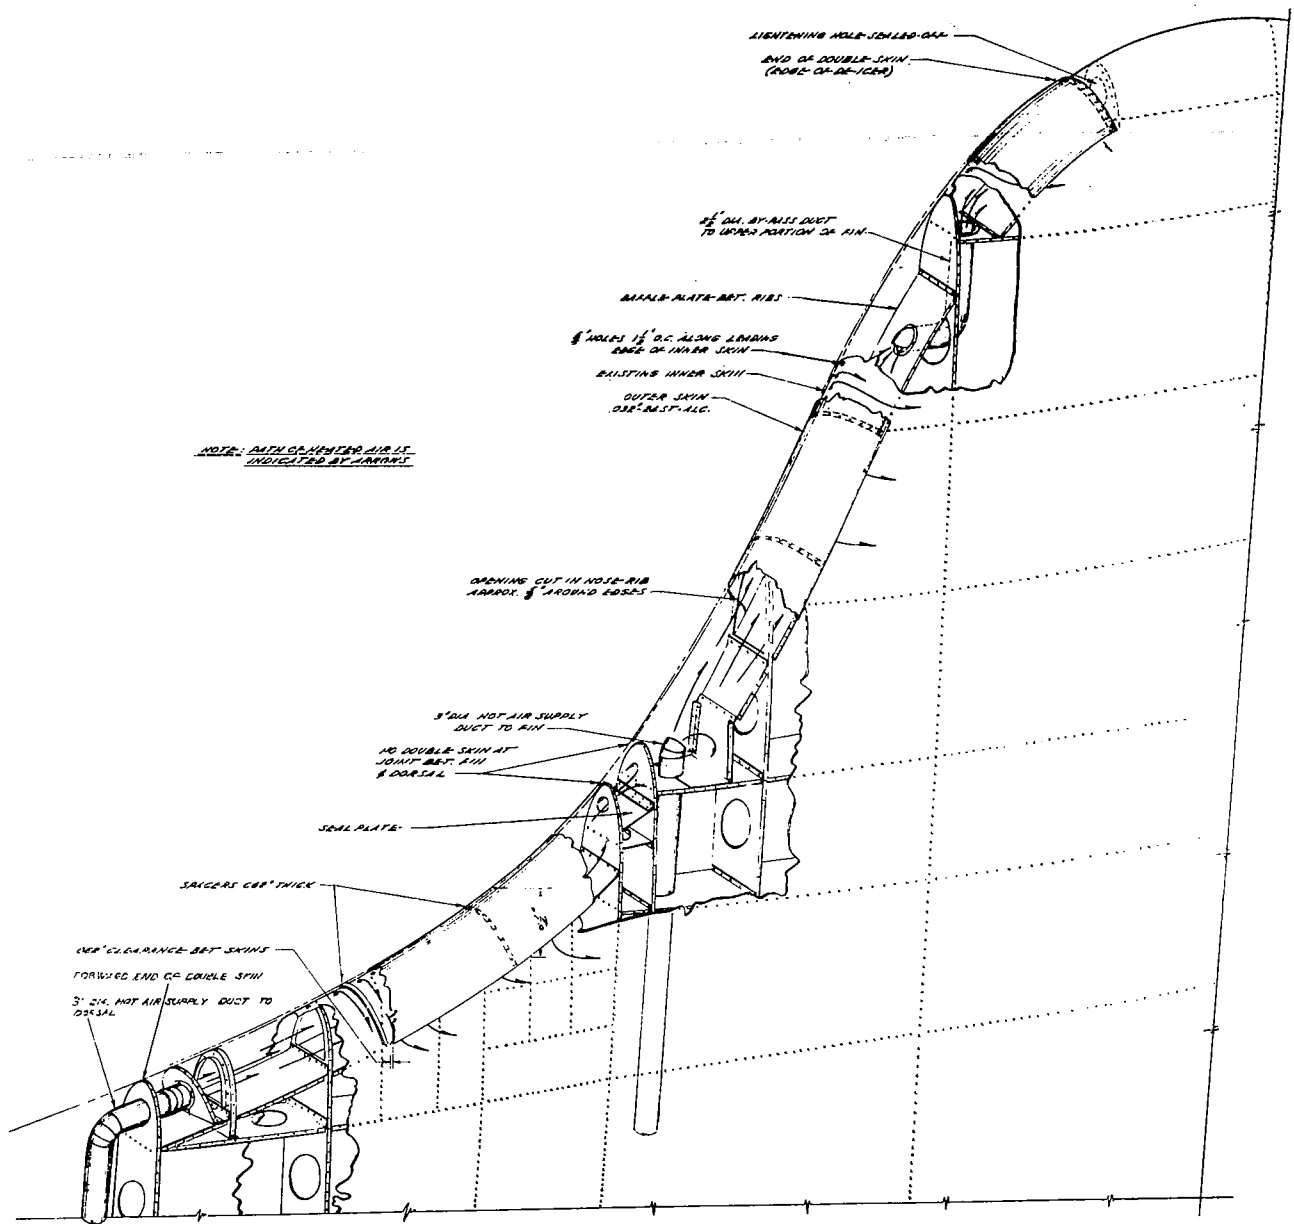
FIGURE 7.- DORSAL AND FIN DESIGN FOR B-17F THERMAL ICE-PREVENTION SYSTEM.

The vertical stabilizer leading edge was heated in a manner similar to the horizontal stabilizer. Heated air was admitted into a gap, formed by the vertical stabilizer skin and an added outer skin, through holes in the leading edge of the inner skin and discharged from the gap at the end of the double-skin region on both sides of the stabilizer. The dorsal and fin systems were essentially separate, being divided at their junction which was not provided with a double skin (fig. 7).
